INSPECTION REPORT

For the Property at:
1627 28 STREET NW
EDMONTON, AB T6T 0K2

Inspection Date: Friday, March 24, 2017

RE: Report No. 1003
1627 28 Street NW
Edmonton, AB
T6T 0K2

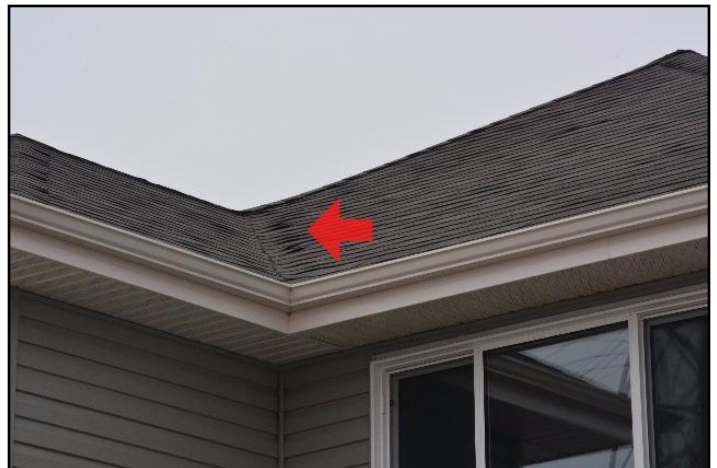
12. Cupping, curling, clawing

1. Condition: • [Cupping, curling, clawing](#)

Location: Garage roof and Top roof

Task: Further evaluation

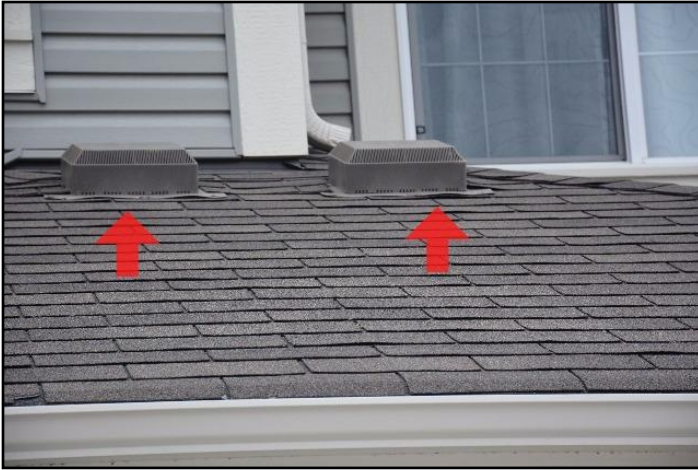
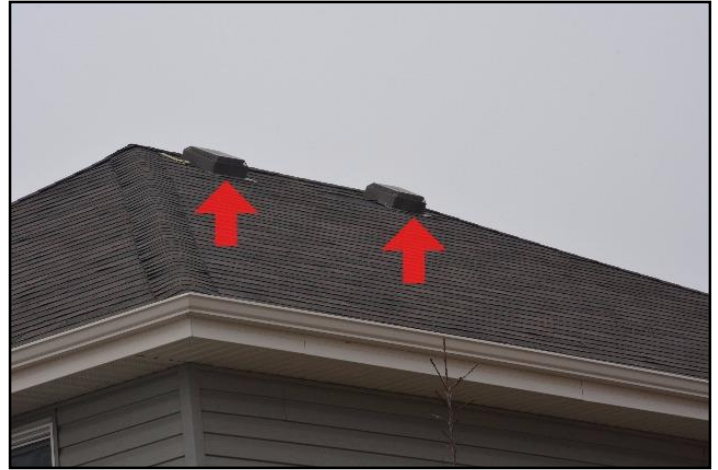
3. Condition: • Loose static vent flashing on garage roof and top roof was noted at the time of inspection. Also noted that yellow belt was left on roof after installing roof. Recommended to remove belt when opportunity arrives.

14. Loose flashing

15. Loose flashing

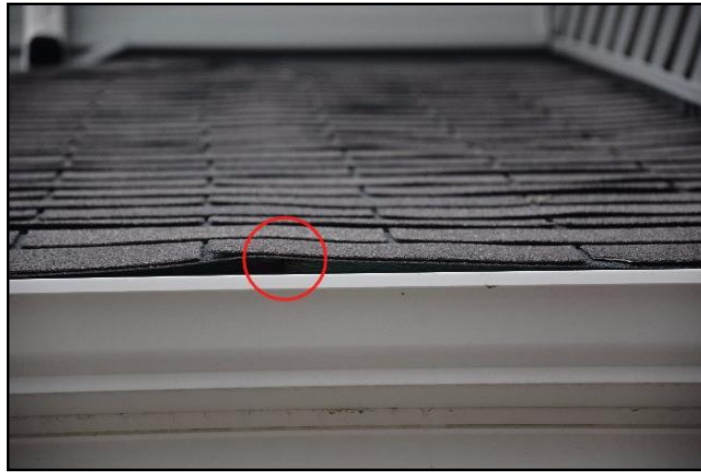
16. *Missing*

Drip edge flashing was missing on right side of garage roof.

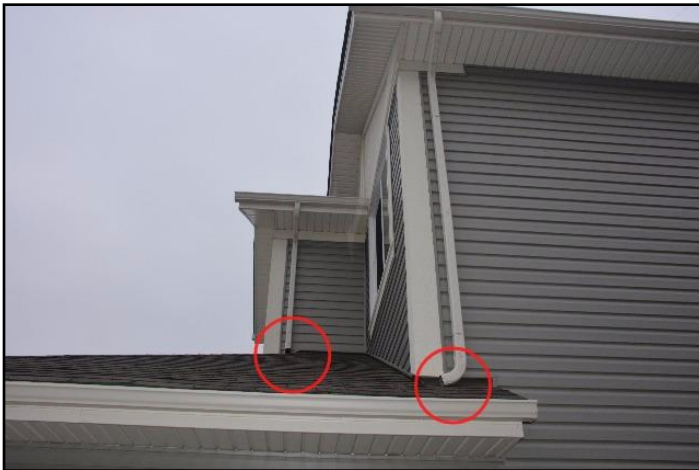
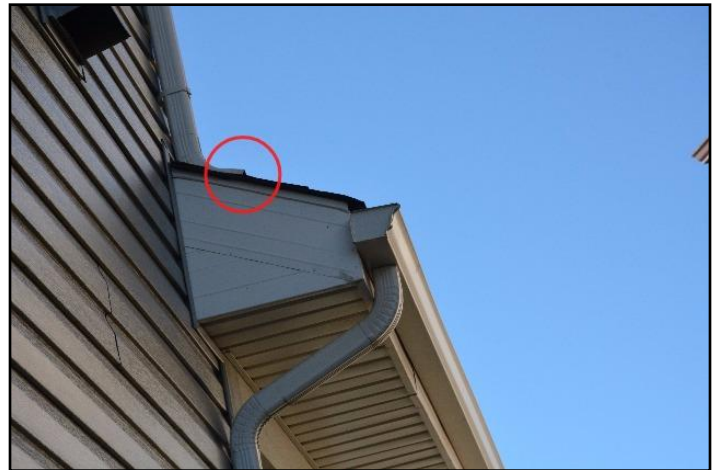
5. Condition: • [Downspouts discharging onto roofs](#)

18. Downspouts discharging onto roofs

19. Downspouts discharging onto roofs

installing a downspout (from the secondary roof to the main gutter below) helps prevent localized roof wear

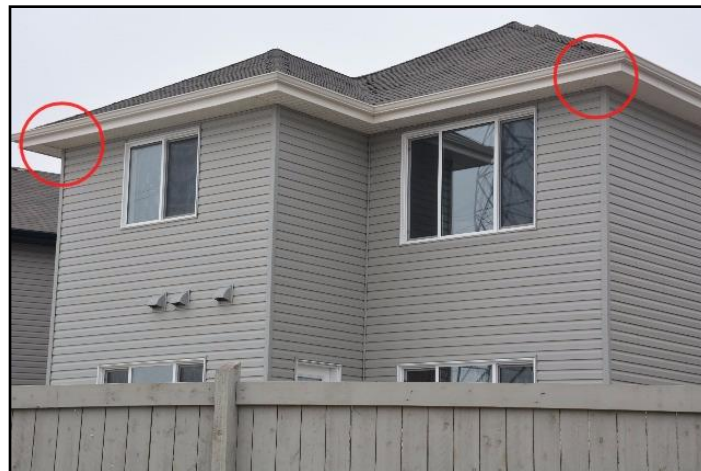
6. Condition: • [Too few](#)

20. Downspout missing

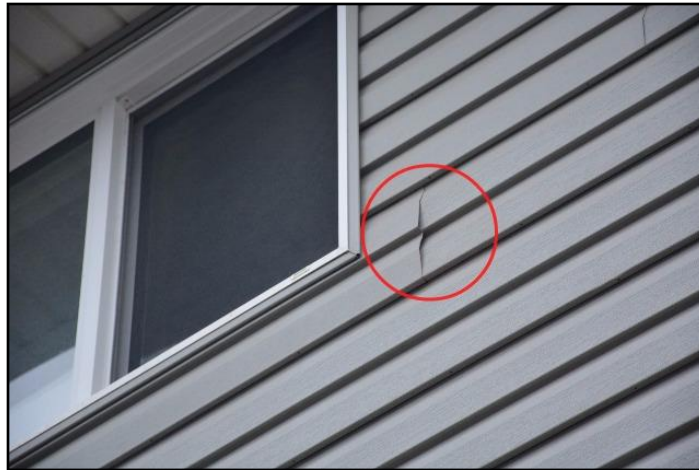
7. Condition: • [Loose or missing pieces](#)

21. Loose or missing pieces

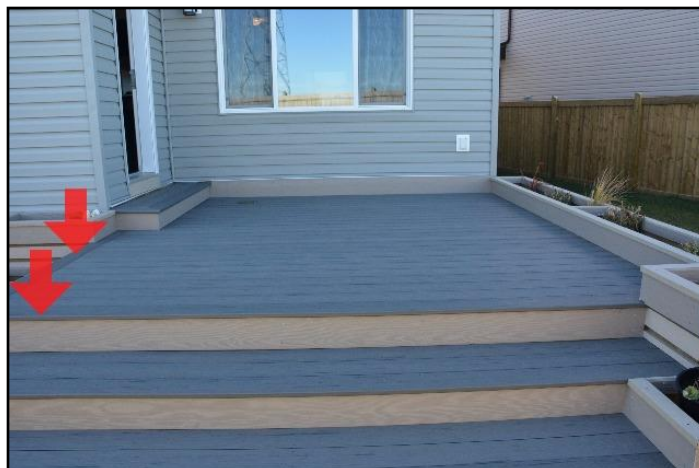
9. Condition: • Deck height was equal or less than 24". Based on the deck height handrail is not mandatory requirement however, it is recommended for the safety of small children.

22. Handrail recommended

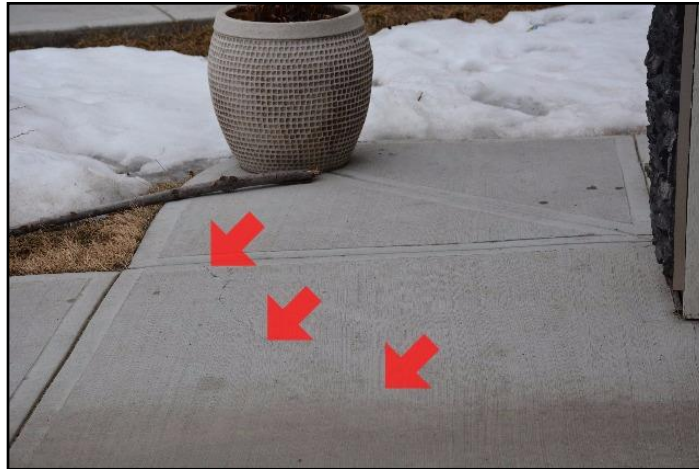
Common hairline crack (a 1/8-inch or less) was observed on the driveway.

23. Hairline Crack

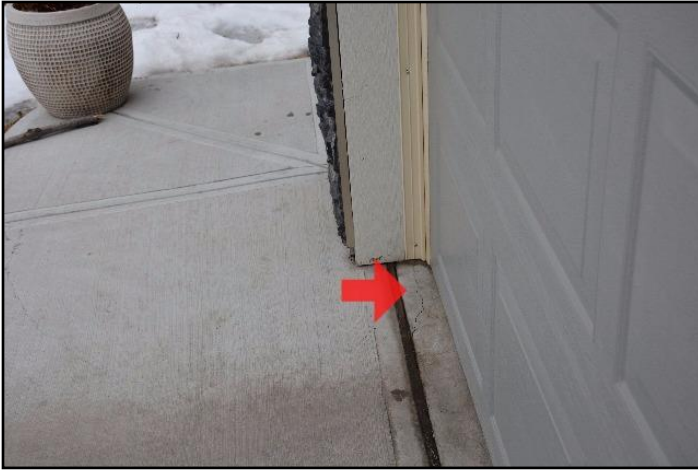
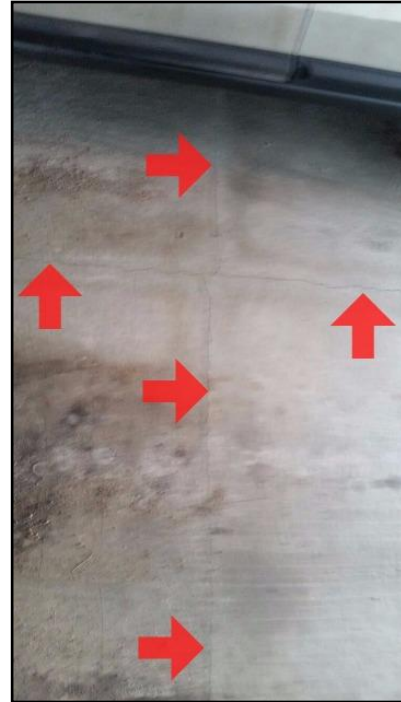
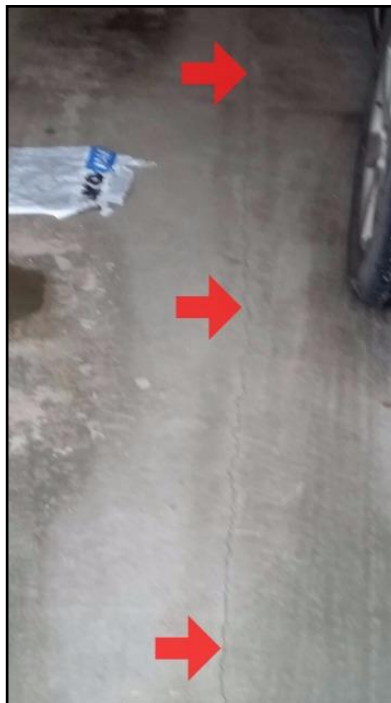
Hairline crack were noted in garage floor at the time of inspection.

24. Cracked

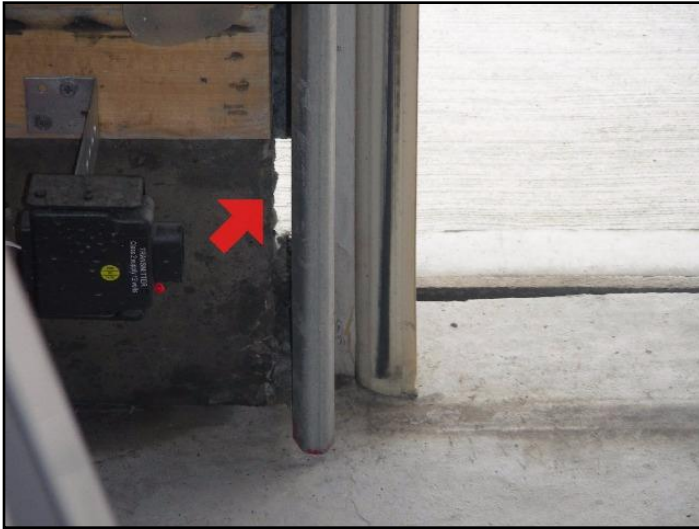
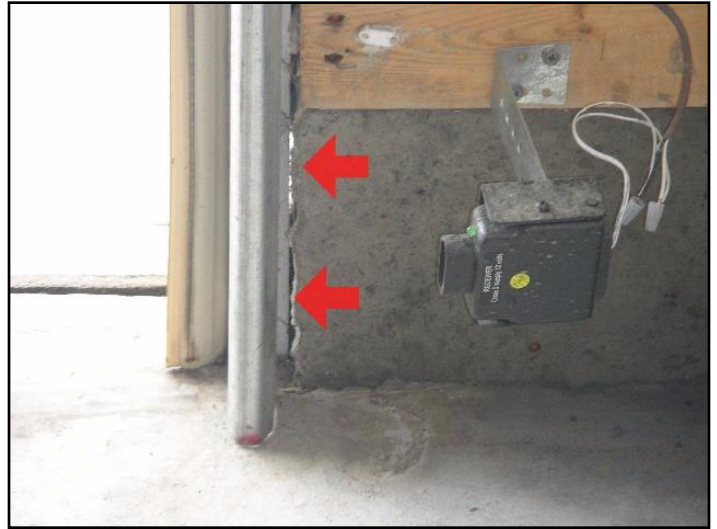
13. Condition: • A gap was noted at front of garage. Recommended to fill with suitable material.

27. Gap

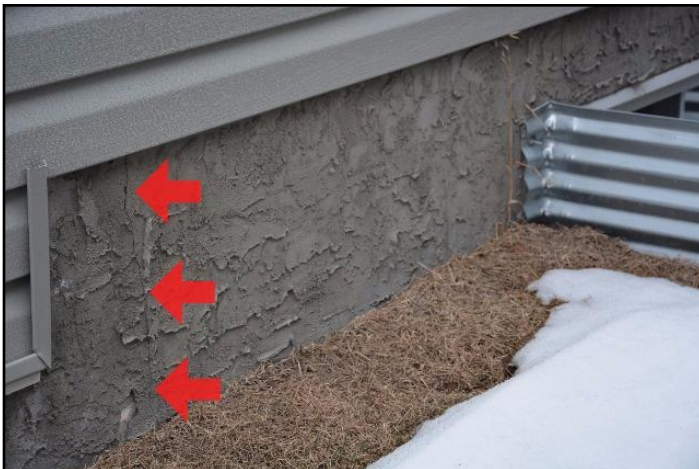
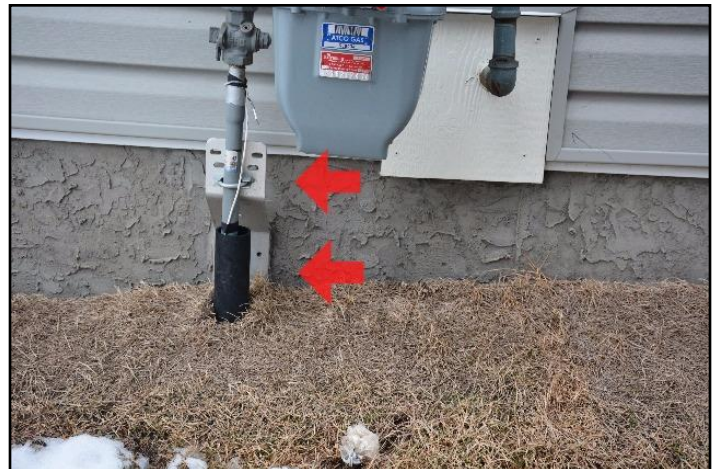
15. Condition: • Typical minor cracks

35. Typical minor cracks

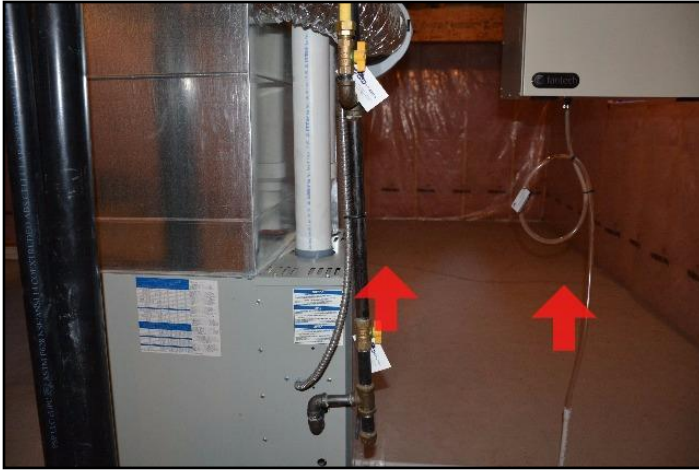
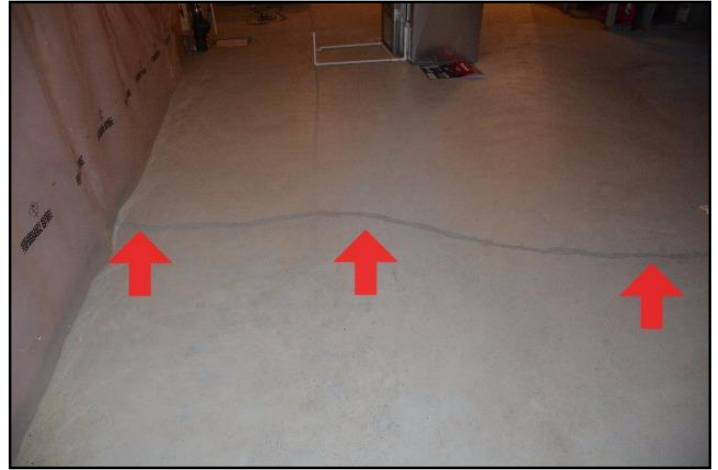
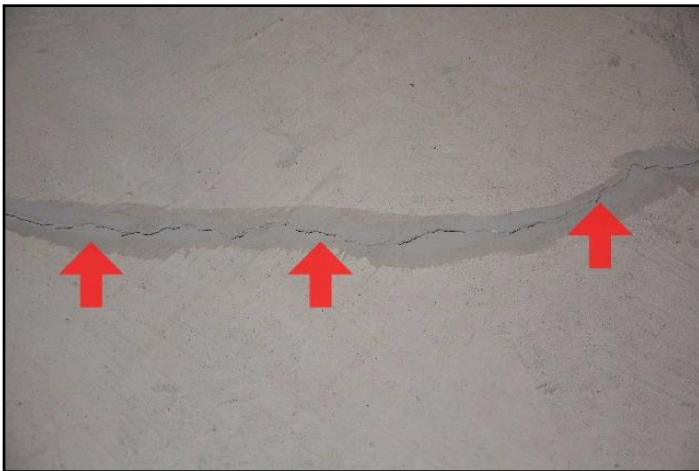
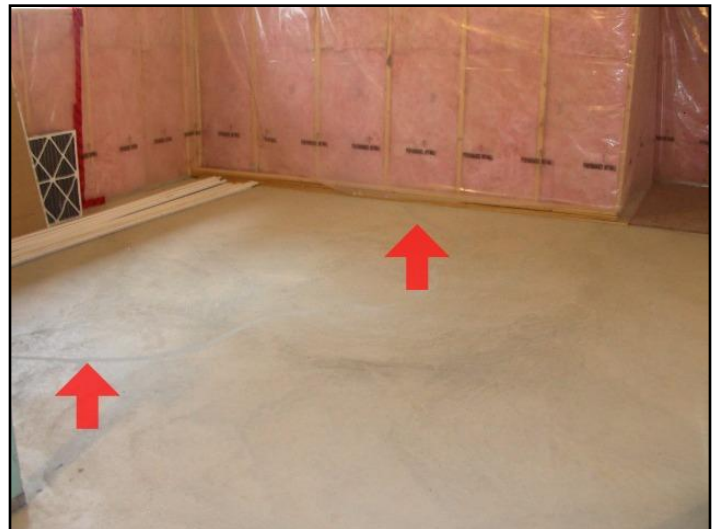
16. Condition: • Repaired minor cracks were observed at the time of inspection.

37. Crack (repaired)

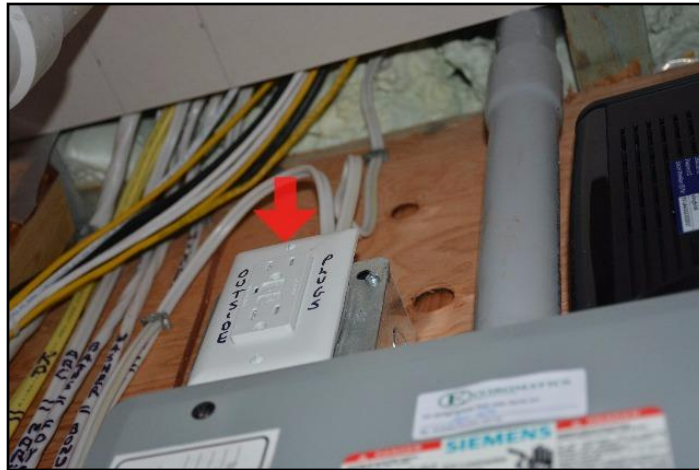
47. GFCI reset - Exterior

Reference photo of GFCI reset located in basement for all exterior outlets. It is recommended to install GFCI receptacle to exterior (front and rear) to prevent unnecessary movement to basement for reset in case of trip.

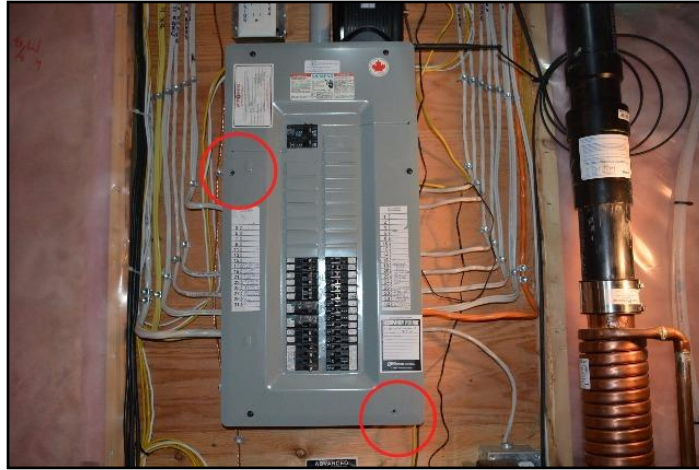
Missing panel cover screw noted at the time of inspection. Install proper panel screw

50. Missing screw

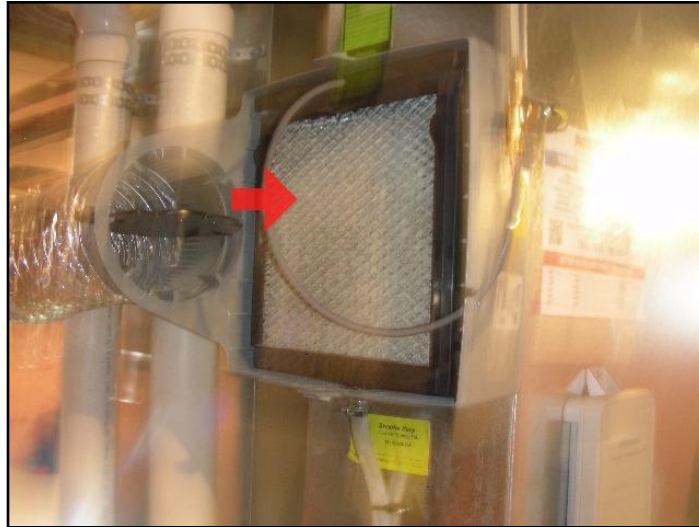
19. Condition: • [Clogged pad, mesh or nozzle](#)

64. Clogged pad, mesh or nozzle

Task: Clean or Replace

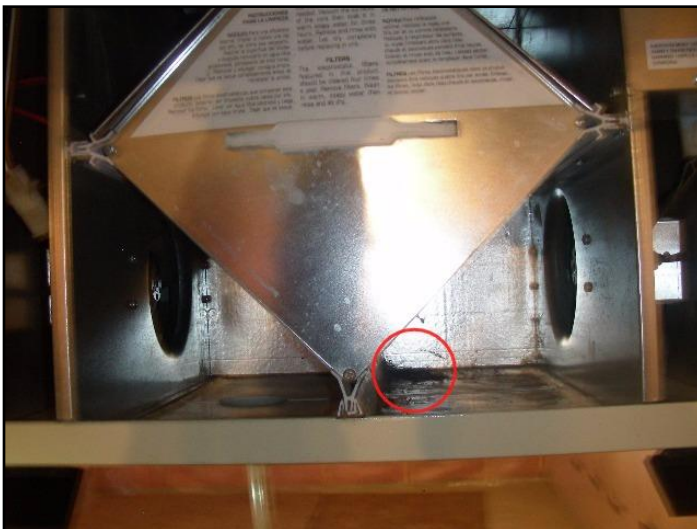
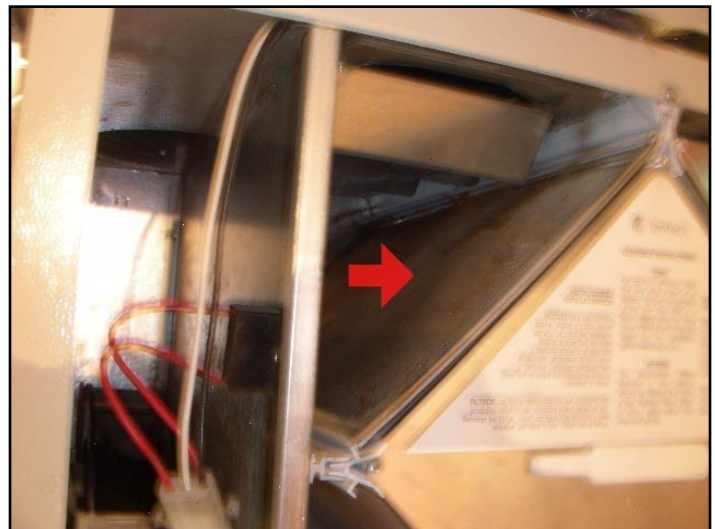
Inside unit and fresh air-intake filter were dirty at the time of inspection. Recommended to clean or replace filter.

65. Dirty

66. Dirty- Fresh air-intake filter

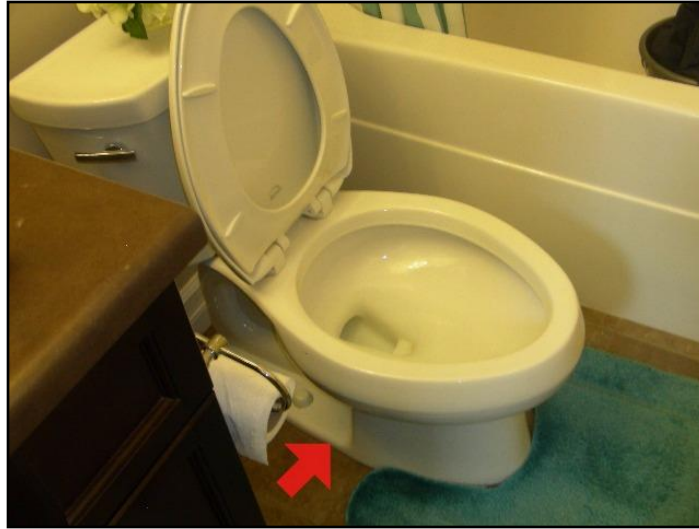
Toilet was loose at the time of inspection. Provide caulking all around the toilet

84. Loose

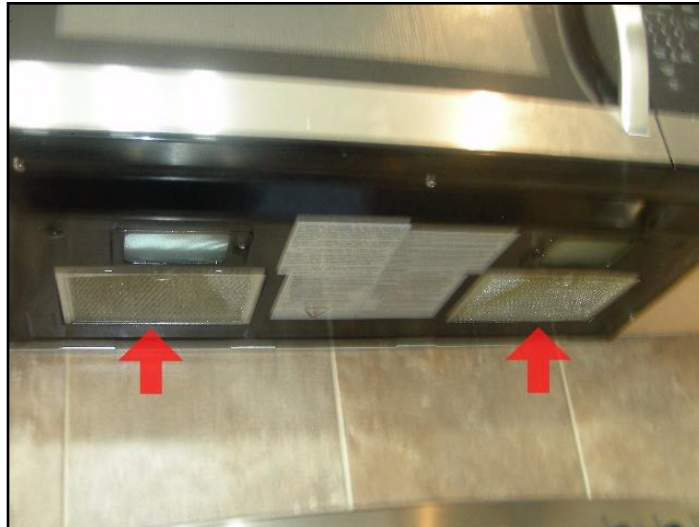
Dirty filters noted at the time of inspection. Recommended to clean filters ongoing

90. *Dirty filter*
