INSPECTION REPORT

For the Property at:
1627 28 STREET NW
EDMONTON, AB T6T 0K2

Inspection Date: Friday, March 24, 2017

RE: Report No. 1003
1627 28 Street NW
Edmonton, AB
T6T 0K2

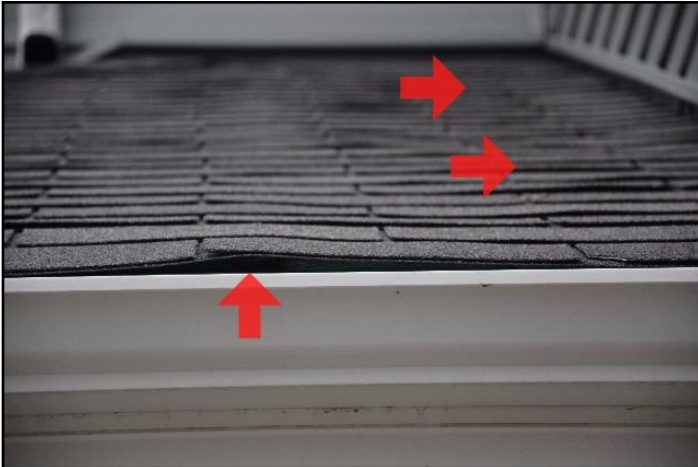
9. Cupping, curling, clawing

1. Condition: • [Cupping, curling, clawing](#)

Implication(s): Chance of water damage to contents, finishes and/or structure

Task: Further evaluation

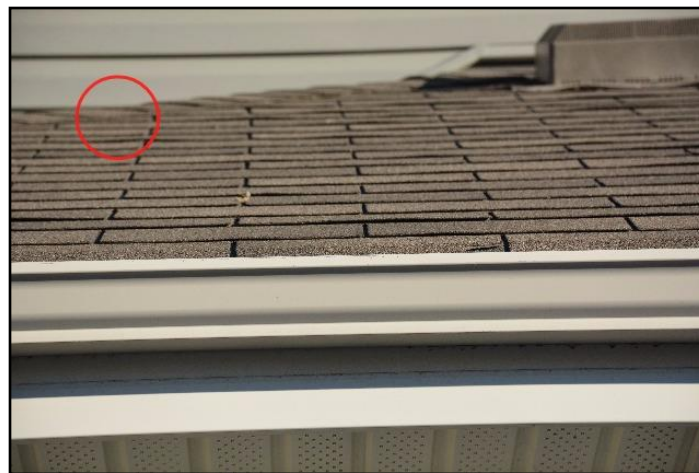
13. Exposed fastener

2. Condition: • [Exposed fasteners](#)

Exposed nail head was observed on garage roof. Any exposed nail heads should be sealed with suitable sealing material to prevent roof leakage.

Implication(s): Chance of water damage to contents, finishes and/or structure

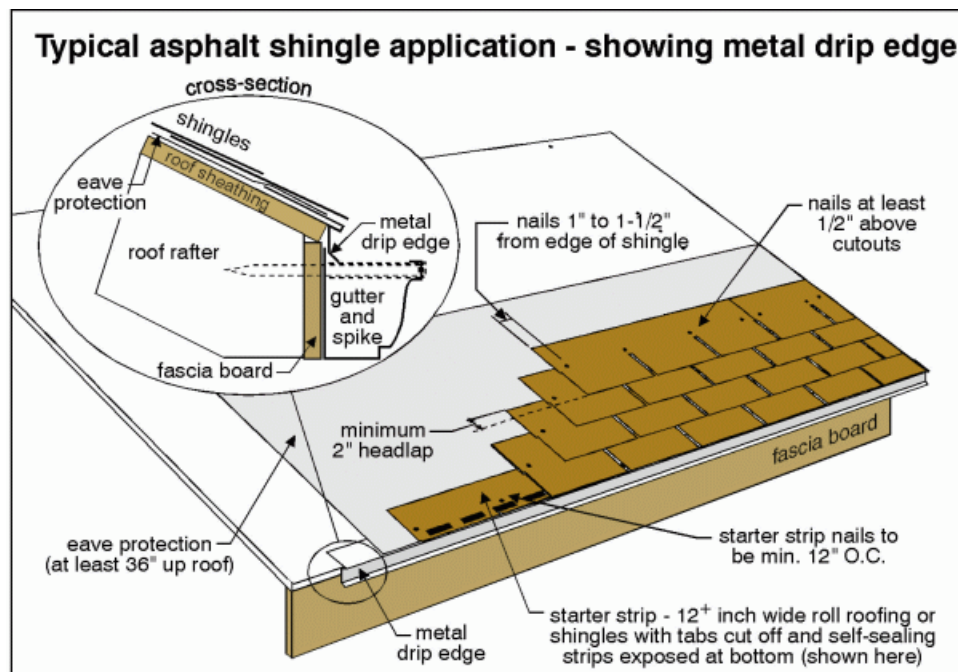
16. *Missing*

4. Condition: • [Missing](#)

Drip edge flashing was missing on right side of garage roof.

Implication(s): Chance of water damage to contents, finishes and/or structure

Task: Provide

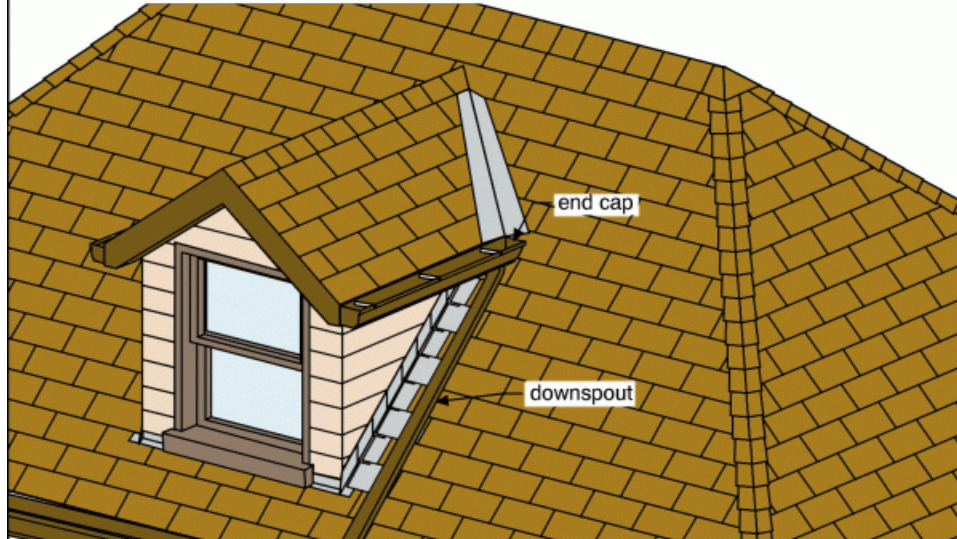
18. Downspouts discharging onto roofs

5. Condition: • [Downspouts discharging onto roofs](#)

Implication(s): Chance of water damage to contents, finishes and/or structure

installing a downspout (from the secondary roof to the main gutter below) helps prevent localized roof wear

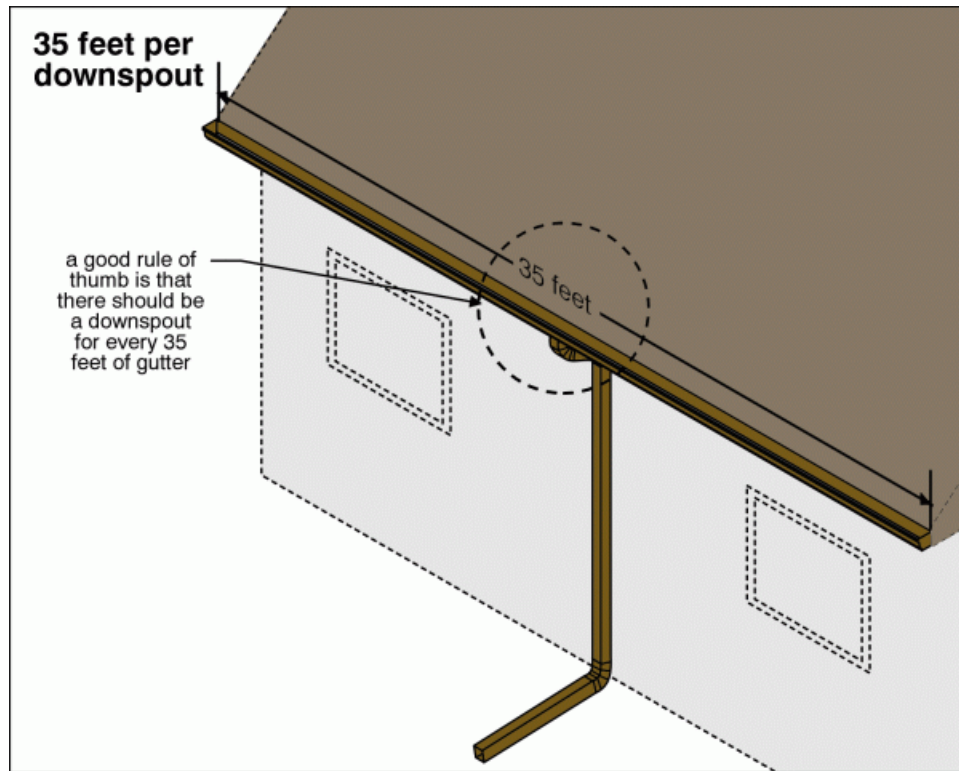
20. Downspout missing

6. Condition: • [Too few](#)

Implication(s): Chance of water damage to contents, finishes and/or structure

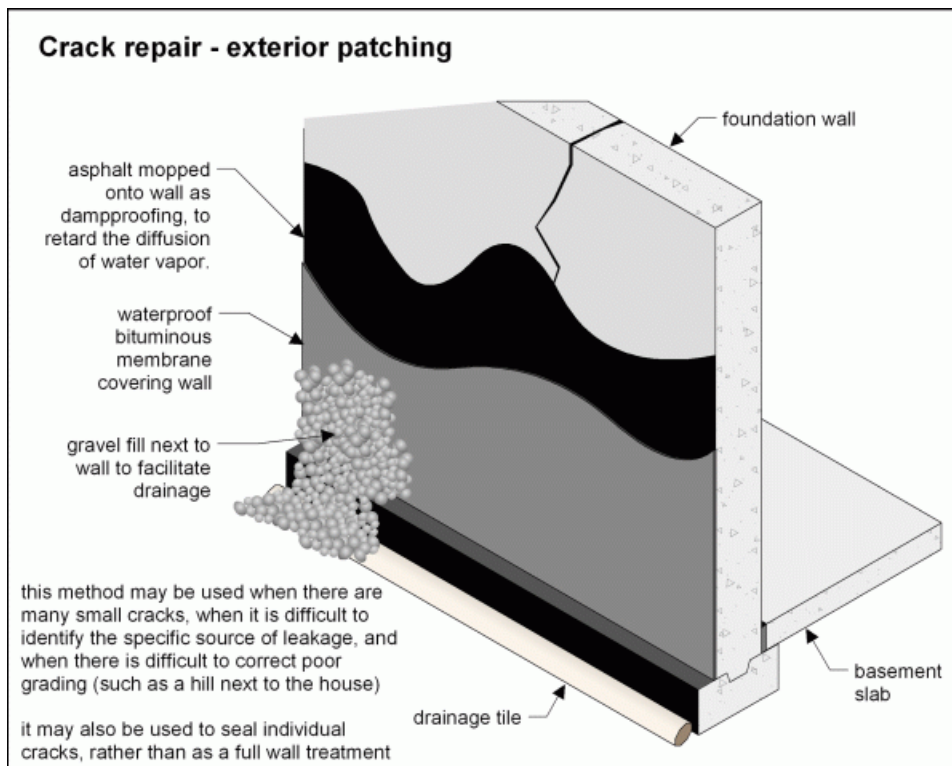
35. Typical minor cracks

15. Condition: • Typical minor cracks

Task: Monitor

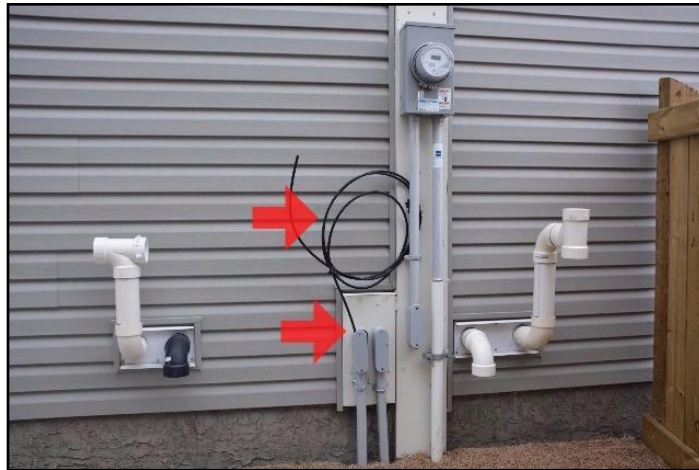
49. Box not weather-tight

17. • Unused communication cable conduit was noted. Recommended to remove or pull inside the basement and close the box weathertight.

Task: Protect

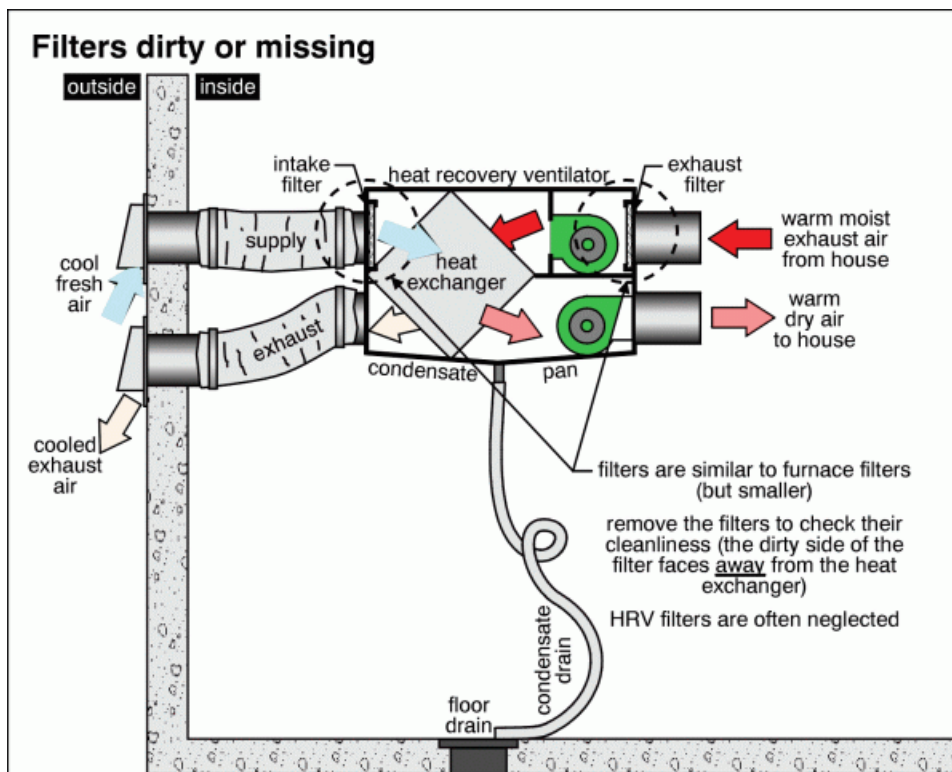
65. Dirty

Inside unit and fresh air-intake filter were dirty at the time of inspection. Recommended to clean or replace filter.

Task: Clean Replace

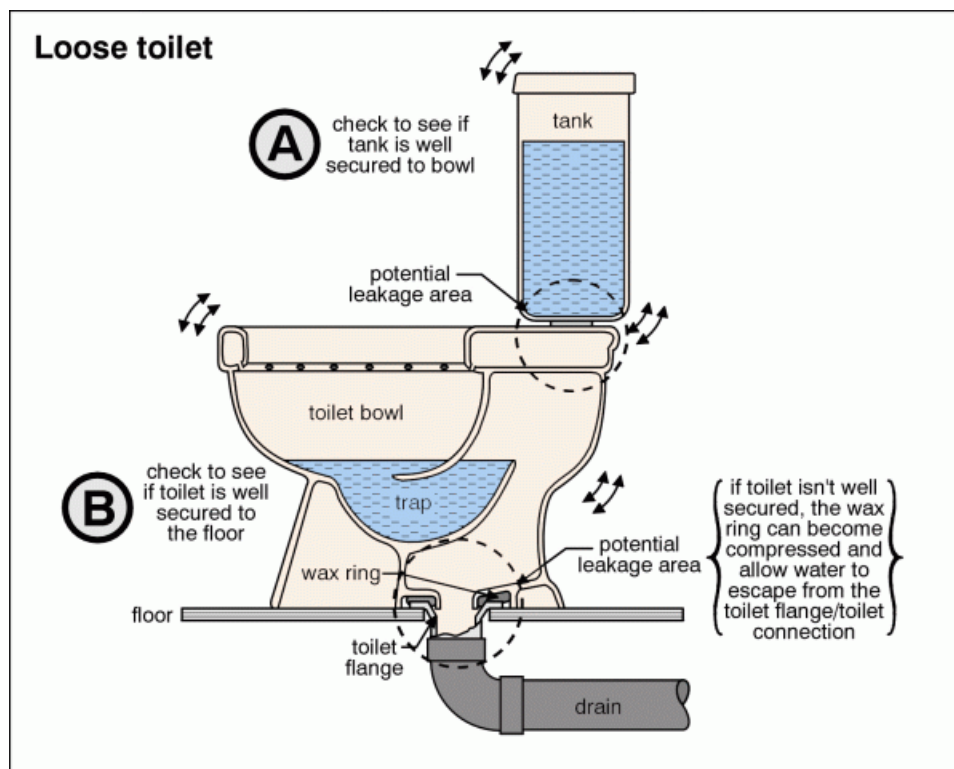
84. Loose

22. Condition: • Loose

Toilet was loose at the time of inspection. Provide caulking all around the toilet

Implication(s): Chance of water damage to contents, finishes and/or structure | Sewage entering the building

Task: Correct

Time: Immediate

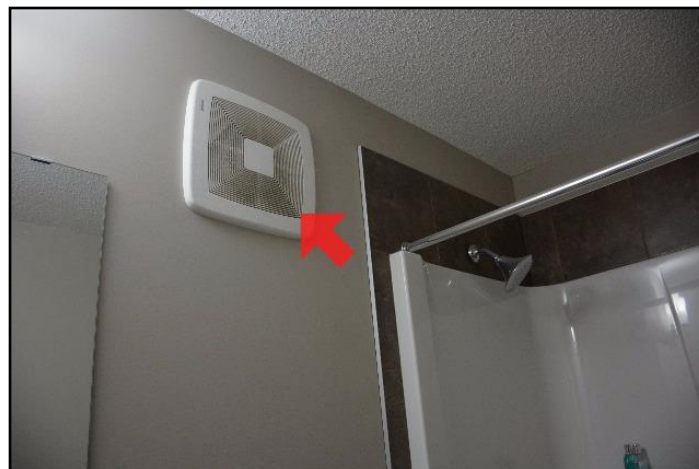
89. Dirty grille

23. Condition: • Second floor common bathroom exhaust fan grille was dirty at the time of inspection. Recommended to clean ongoing to prevent moisture problem.

Task: Clean

Time: Ongoing
